**CHASE MILL DAM  
ME-00335**

**PHASE I INSPECTION REPORT  
NATIONAL DAM INSPECTION PROGRAM**

**MAY 1979**

November 28, 1978

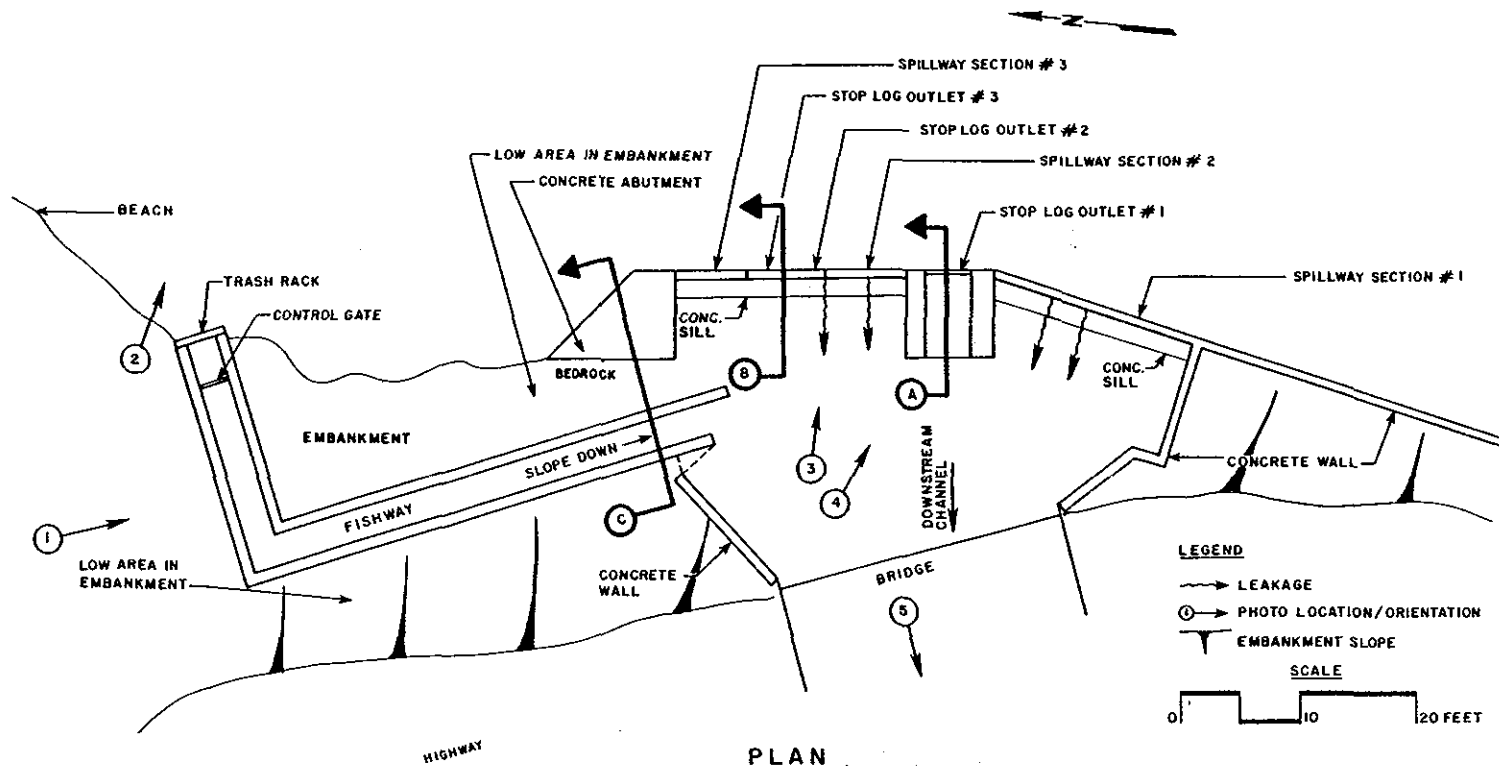
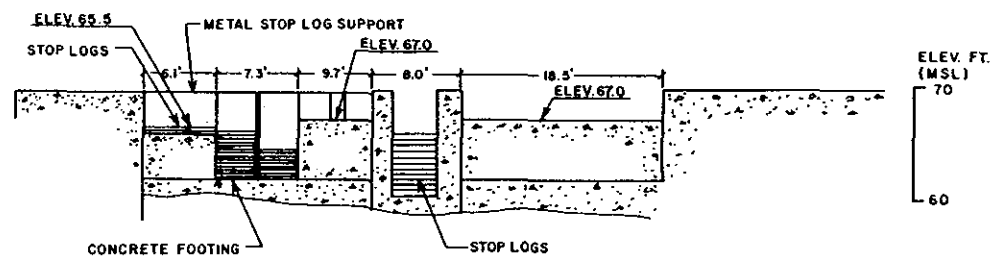
EDWARD C. JORDAN CO., INC.		U.S. ARMY ENGINEER DISTRICT NEW ENGLAND	
PORTLAND, MAINE		CONTRACT NO. 1555	
NATIONAL PROGRAM OF INSPECTION OF NON-FED DAMS		DATE: MARCH 1979	
CHASE MILL STREAM		SCALE: AS SHOWN	
MAINE		DATE: MARCH 1979	
2079317		CHASE MILL DAM	
		PLAN & PROFILE
